Mima Capital LLC
4120 Douglas Blvd, #306-175
Granite Bay, California, 95746

Project No. E22116.000
29 March 2022

Subject: **CALLISON ROAD (7615)**
7615 Callison Road, Penryn, California
SLOPE STABILITY STUDY FOR SEPTIC LEACH FIELD

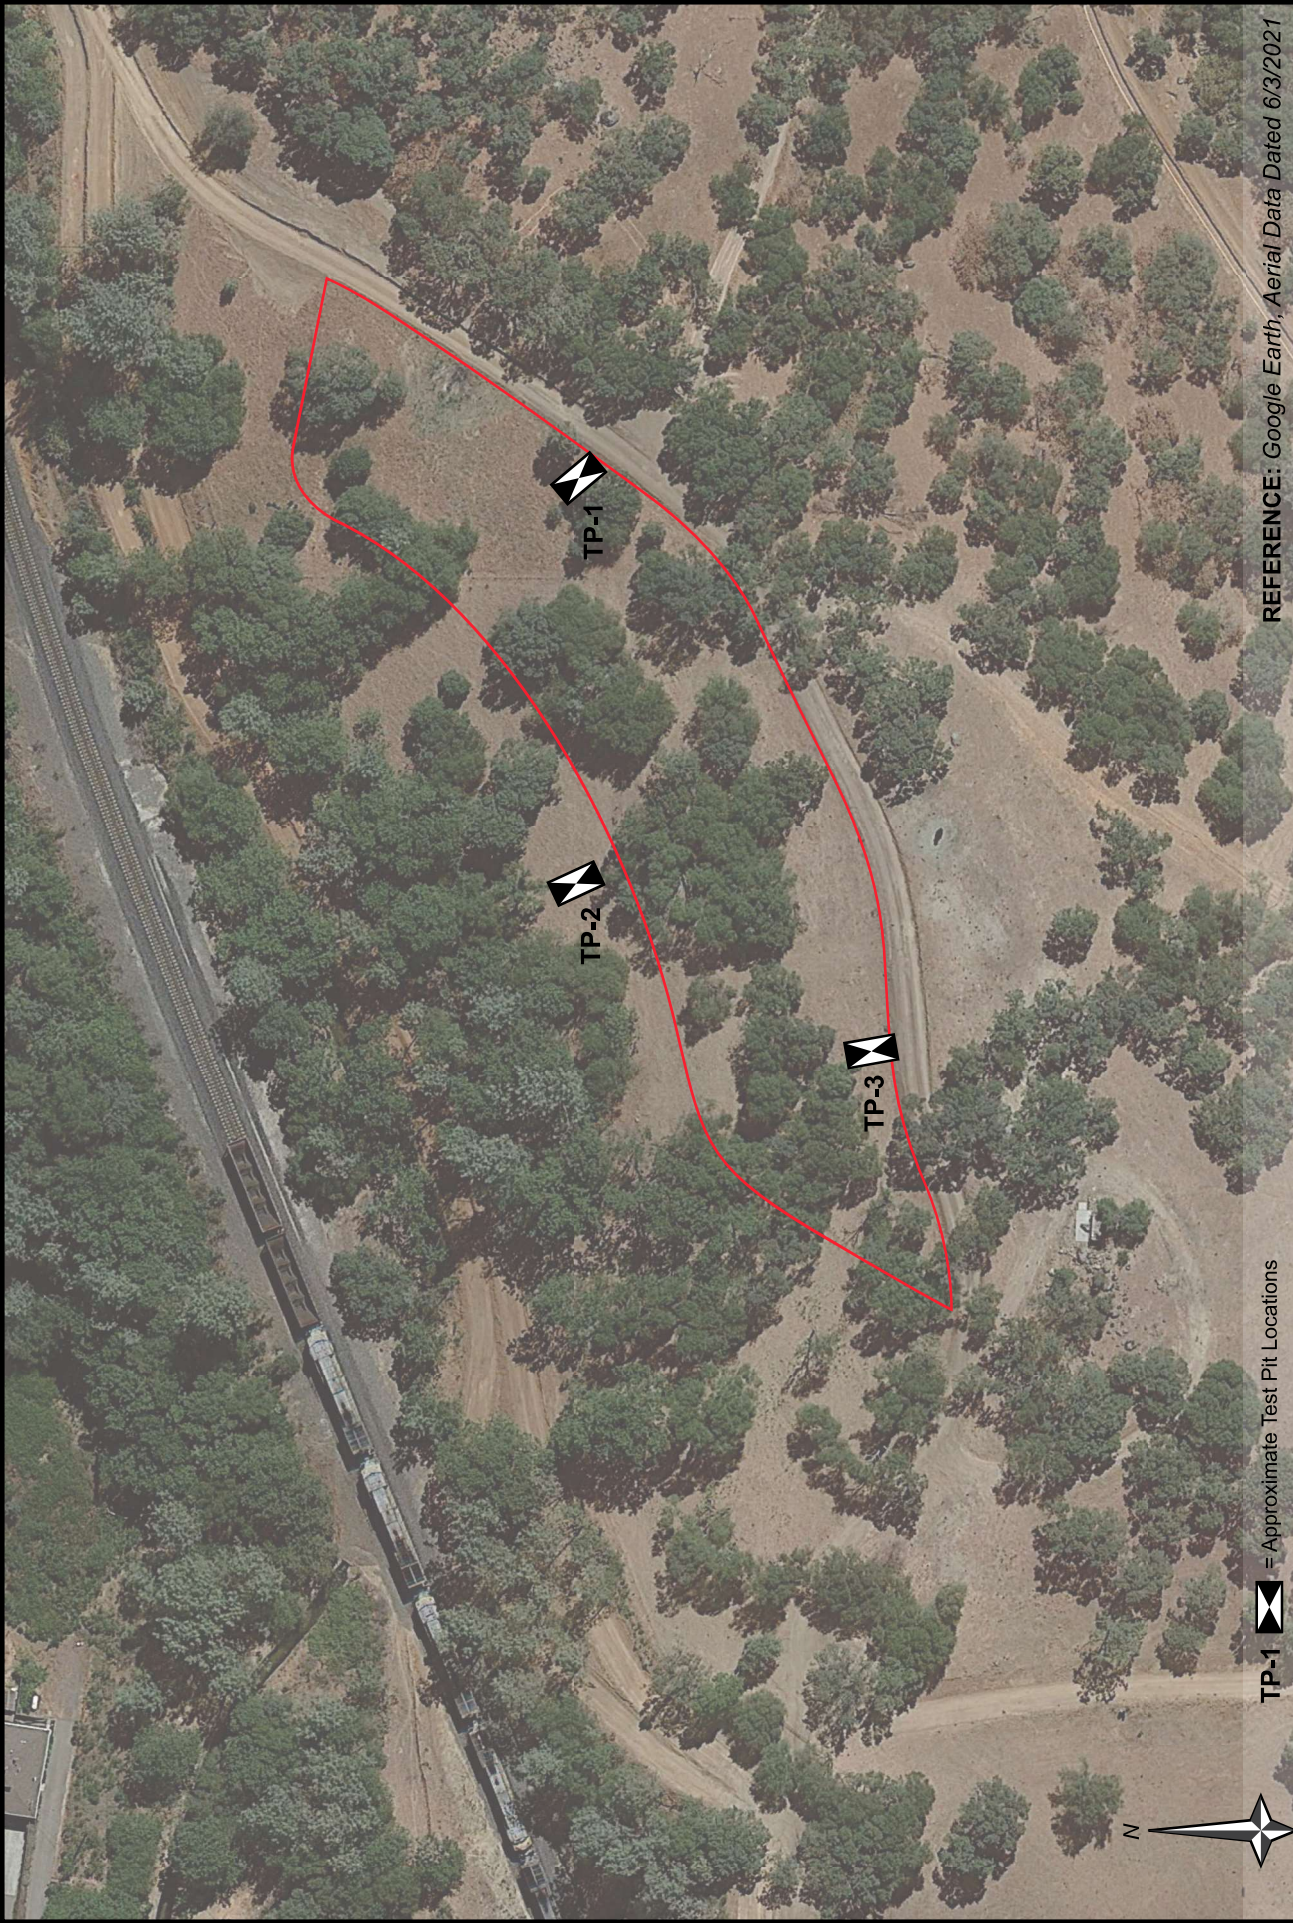
FIGURE
A-2

Our field study included a site reconnaissance by a representative of our firm and a subsurface exploration program. The exploration program included the excavation of 3 test pits to evaluate the near surface soils conditions and the depth to rock. The approximate locations of the test pits are presented on Figure A-2, Appendix A.

TP-1 = Approximate Test Pit Locations

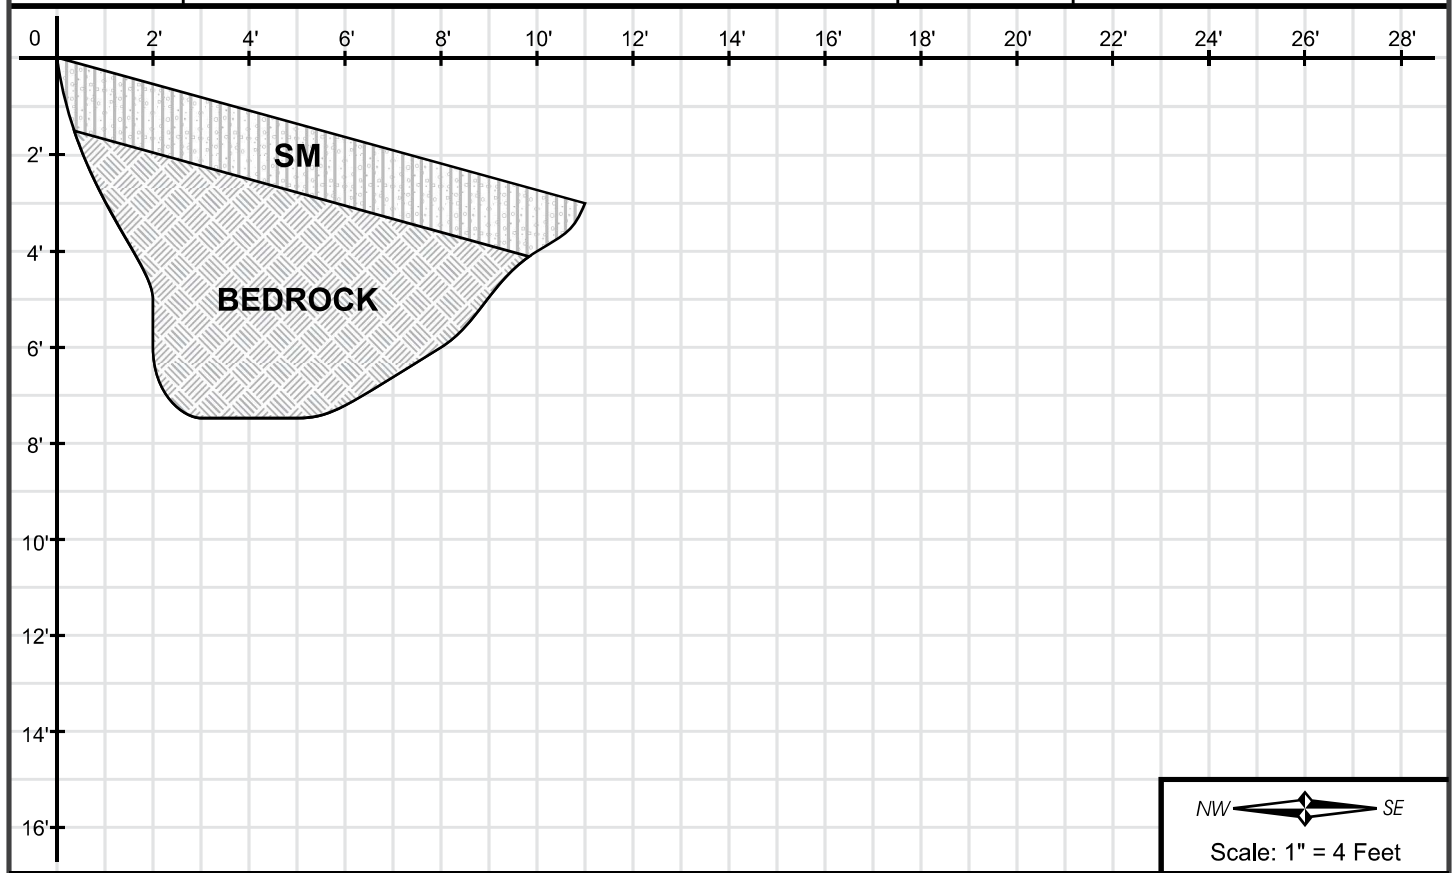
FIGURE

Depth (Feet)	Geotechnical Description & Unified Soil Classification	Sample	Tests & Comments
@ 0' - 2'	Brown to yellow brown silty SAND (SM) , medium to dense, slightly moist to moist		DD: 105.3 pcf M: 10.4%
@ 2' - 2.5'	Red yellow to olive yellow sandy CLAY (CL) , stiff, moist		DD: 98.9 pcf M: 24.7%
@ 2.5' - 4'	Red yellow BEDROCK , highly weathered, moderately hard, slightly moist		DD: 107.4 pcf M: 12.4%
@ 4' - 8'	<i>Grades red yellow to pink, dry</i>		
	Test pit terminated at 8' No free groundwater encountered No caving noted

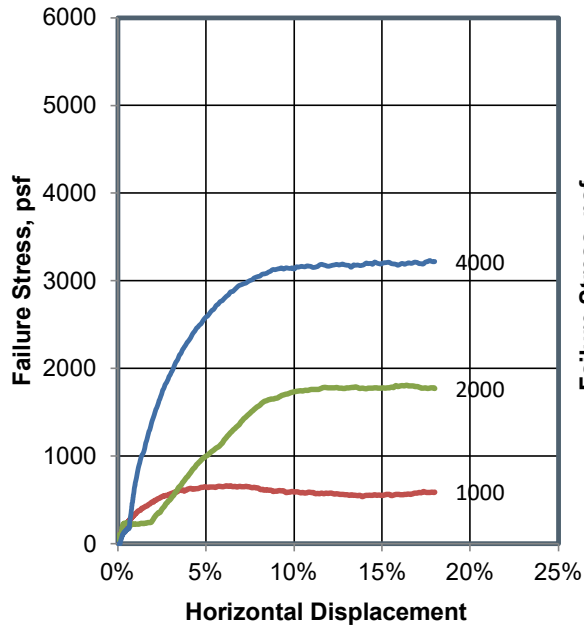
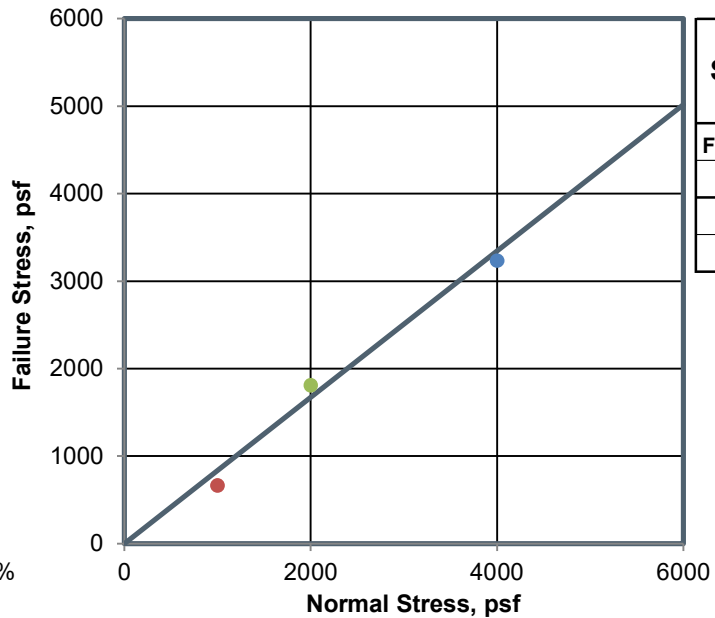
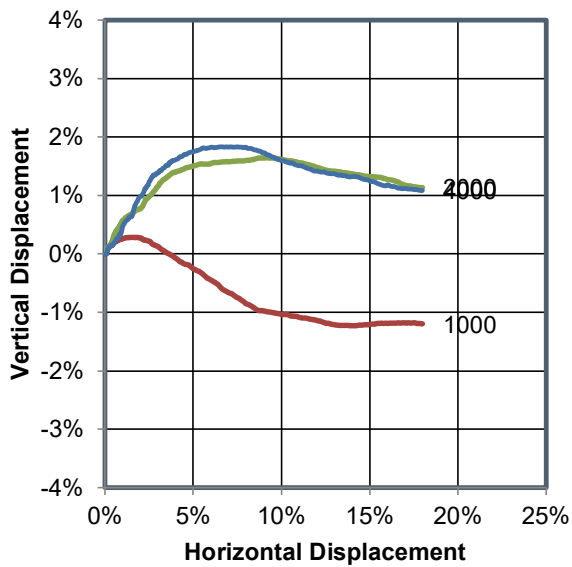
Figure
B-1

Laboratory Test	Test Standard	Summary of Results	
Direct Shear	ASTM D3080	TP @ 1.5-2'	$\Phi = 39.9^\circ$, $c = 0$ psf (Remolded to field measured density and moisture content)

Direct Shearbox Results	
Friction Angle	39.9°
Cohesion	0 psf

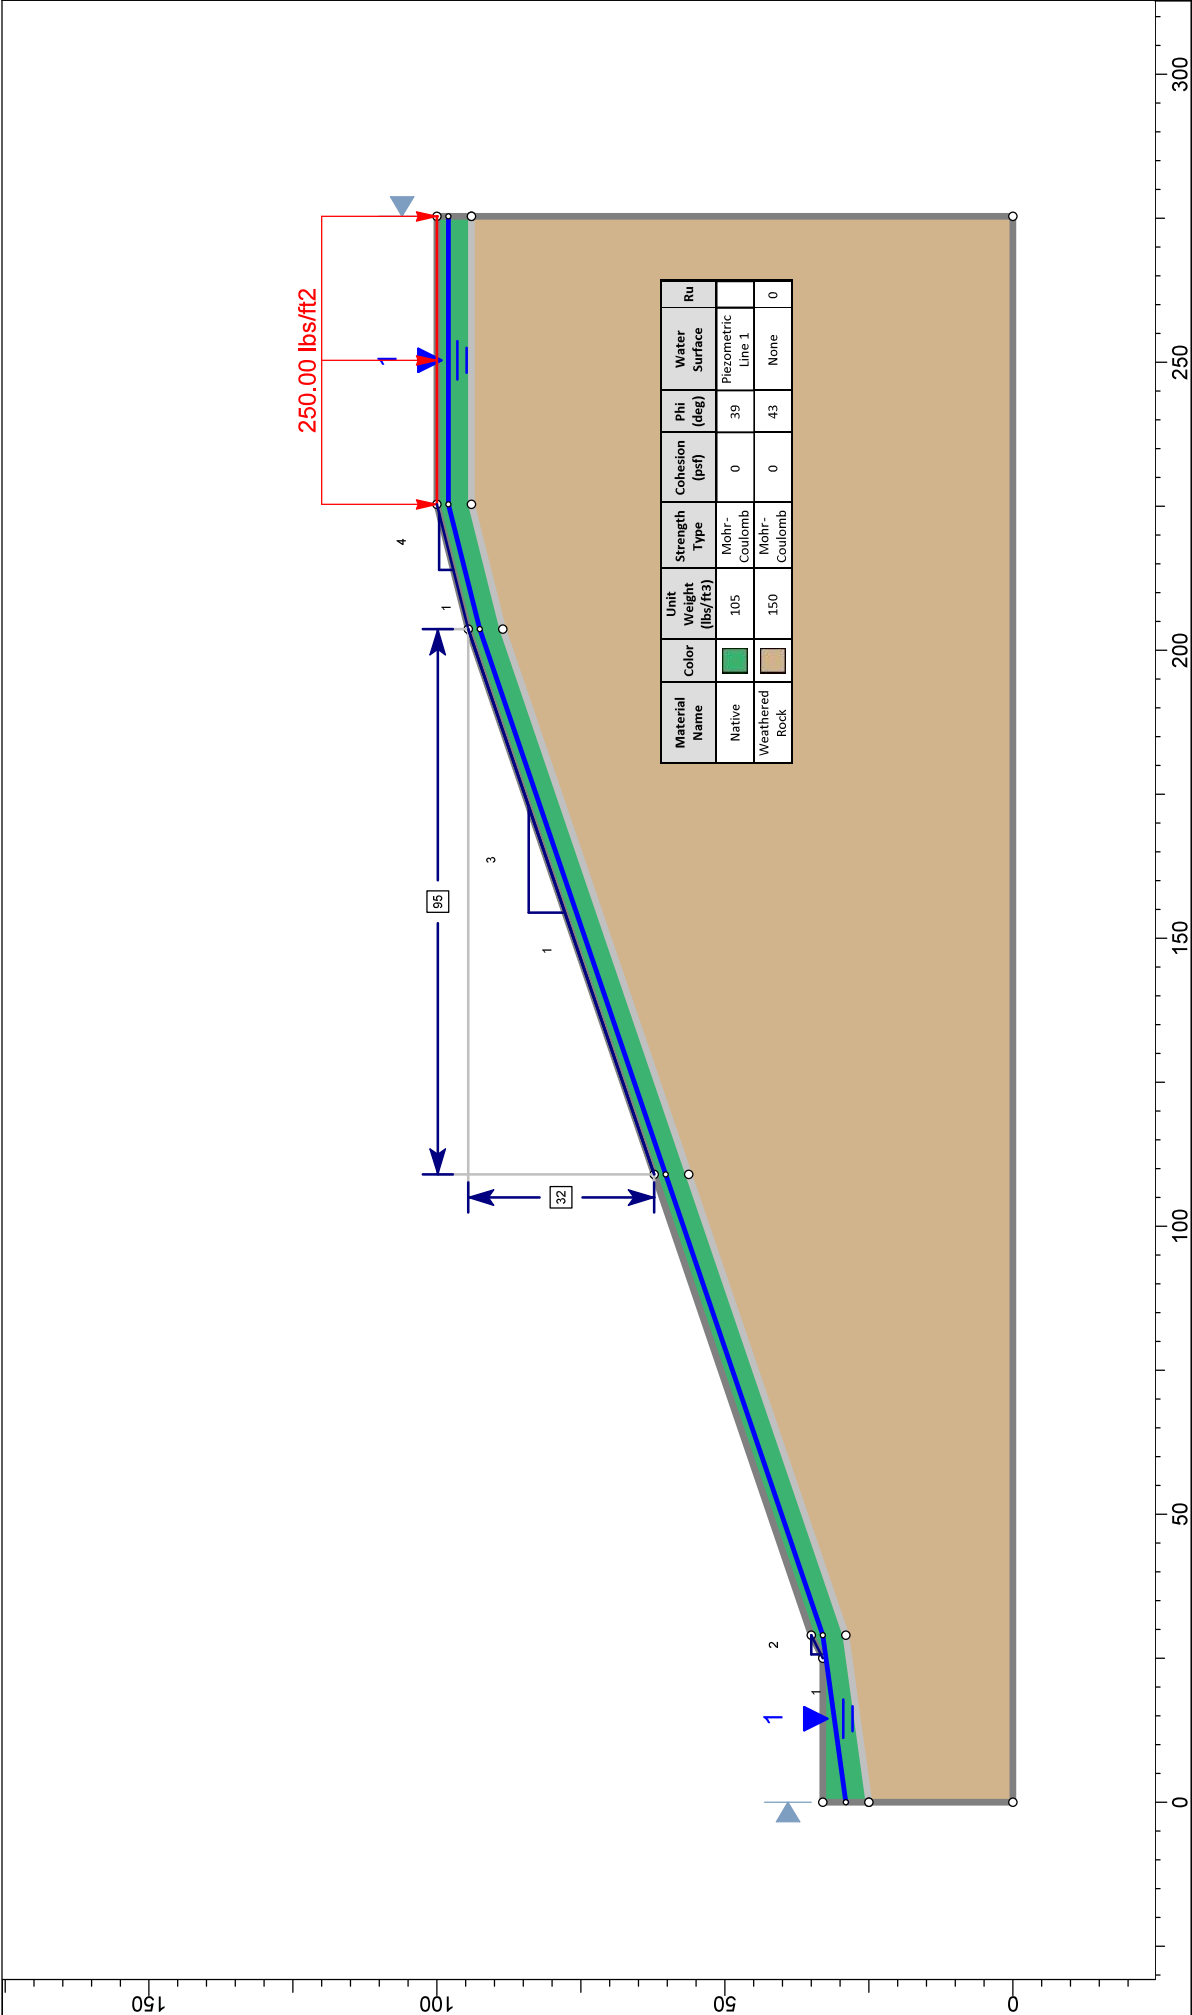
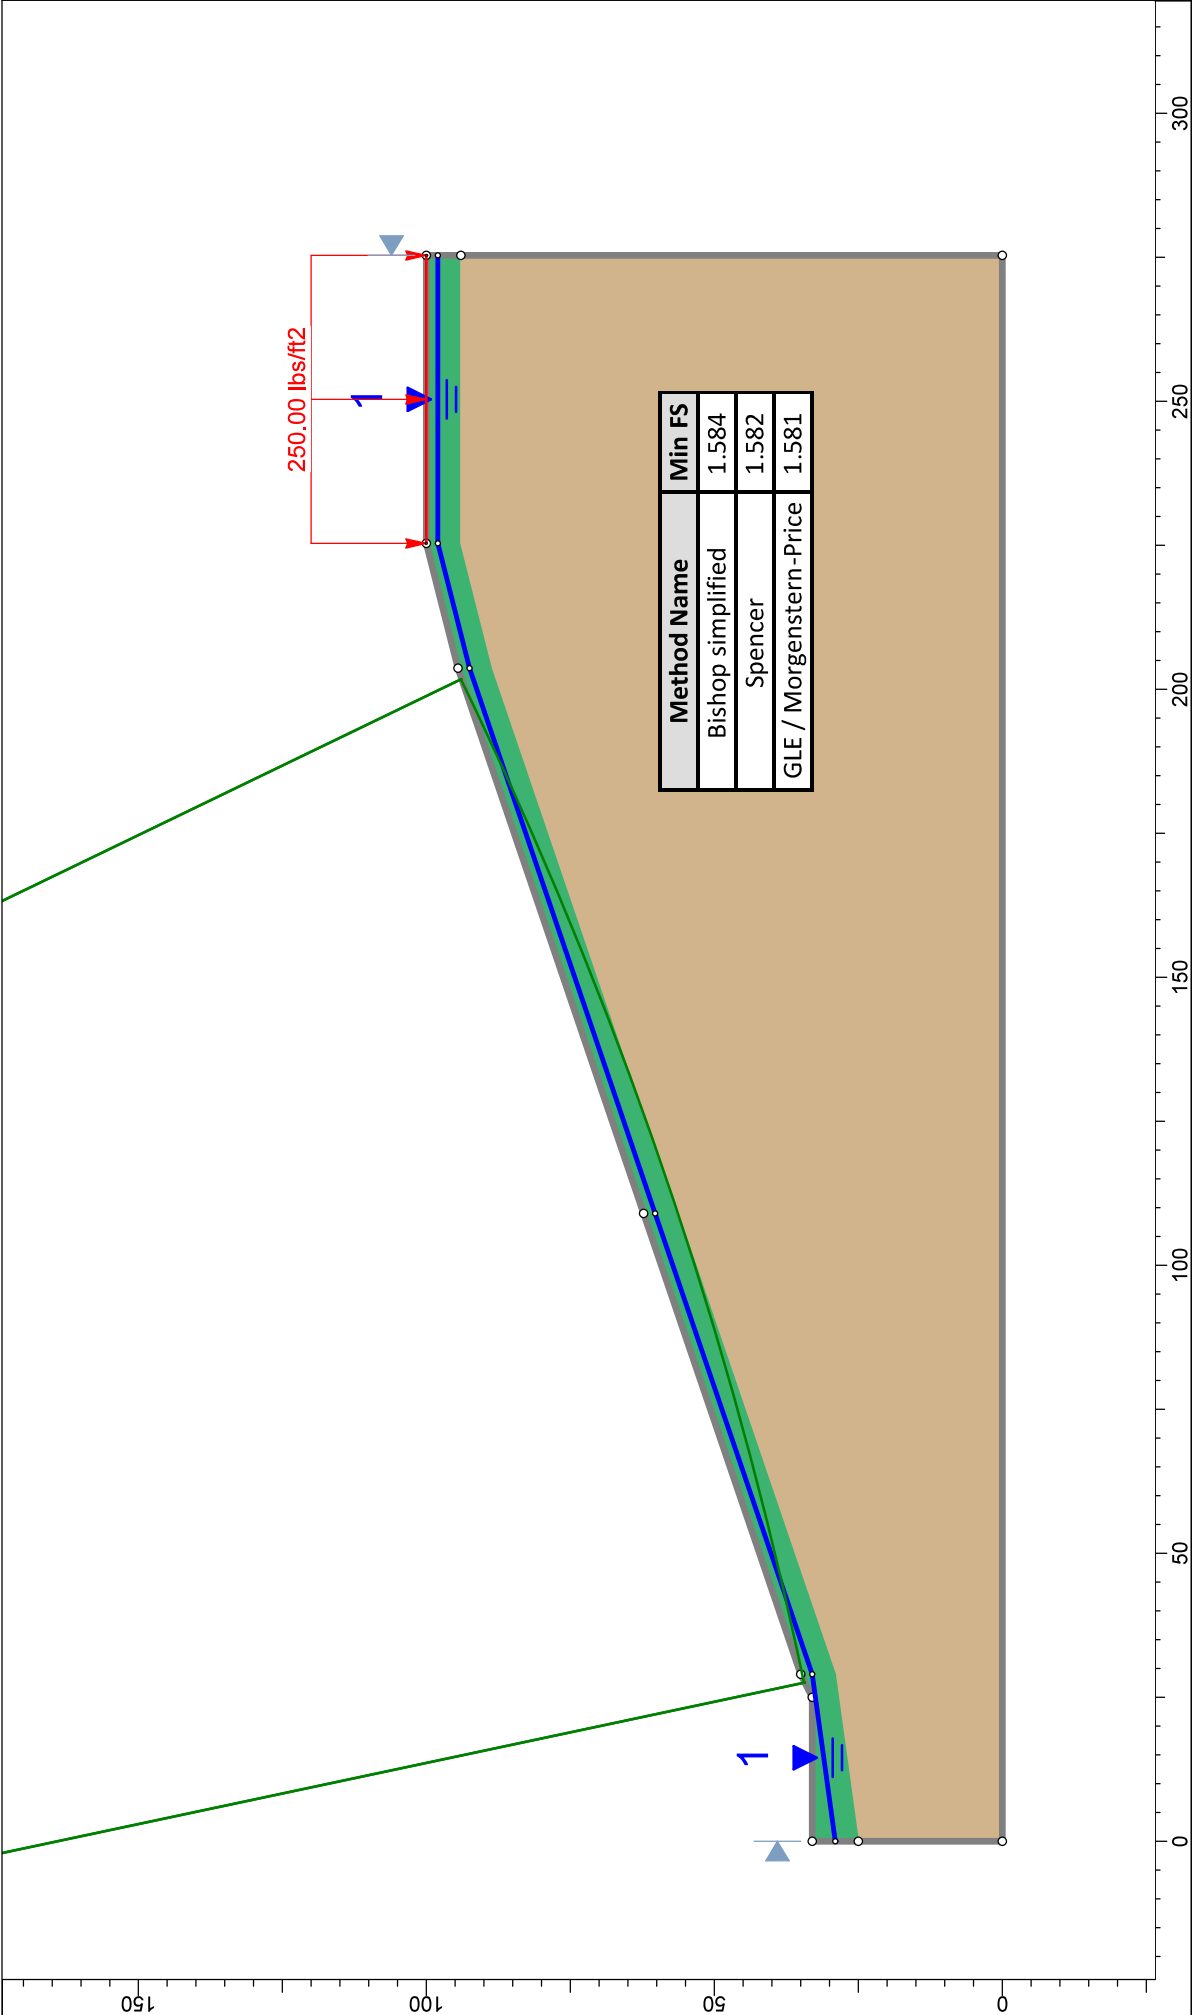
Static Analysis

In assessing the slope conditions for stability, we did not consider cohesion in the calculations to evaluate the existing soil and rock conditions to obtain a worst-case scenario factor of safety (FS). Using the parameters in the Soil and Rock Values table above, and with the Spencer and GLE methods, the analyses produced FS values of 1.582 and 1.581, respectively for a static loading. The analyses produced FS values of 1.211 and 1.211, respectively for a seismic loading.

The proposed septic leach field area was observed to be moderately sloping to the southwest at an approximate gradient of 3H:1V with a dense covering of grasses and trees. Based on the modelled slope stability scenario generated from the parameters above and modified soil parameters that provided a conservative FS value, a minimum FS value of 1.5 was obtained. Our analysis revealed that the slope would remain stable under saturated condition with the soil and rock conditions observed in the test pits for proposed leach field area. Please do not hesitate to contact us should you have any questions regarding our slope stability assessment.
